**MARYLAND HISTORICAL TRUST  
DETERMINATION OF ELIGIBILITY FORM**

Property Name: Gwynnbrook Farm House Inventory Number: BA-1746  
Address: 11767 Owings Mills Boulevard Historic district: ☐ yes ☒ no  
City: Owings Mills Zip Code: 21117-2810 County: Baltimore County  
USGS Quadrangle(s): Reisterstown  
Property Owner: State of Maryland Department of Game and Inland Fish Tax Account ID Number: 0419072275  
Tax Map Parcel Number(s): 164 Tax Map Number: 58  
Project: Gwynnbrook Avenue Bridge Replacement Agency: Baltimore County Dept of Public Works  
Agency Prepared By: Whitman, Requardt and Associates, LLP  
Preparer's Name: Sheryl Bernardo Date Prepared: 4/5/2004  
Documentation is presented in: Maryland Historical Trust Inventory Form For State Historic Sites Survey  
Preparer's Eligibility Recommendation: ☒ Eligibility recommended ☐ Eligibility not recommended  
Criteria: ☐ A ☐ B ☒ C ☐ D Considerations: ☐ A ☐ B ☐ C ☐ D ☐ E ☐ F ☐ G  
*Complete if the property is a contributing or non-contributing resource to a NR district/property:*

Gwynnbrook Farm House

## INVENTORY FORM FOR STATE HISTORIC SITES SURVEY

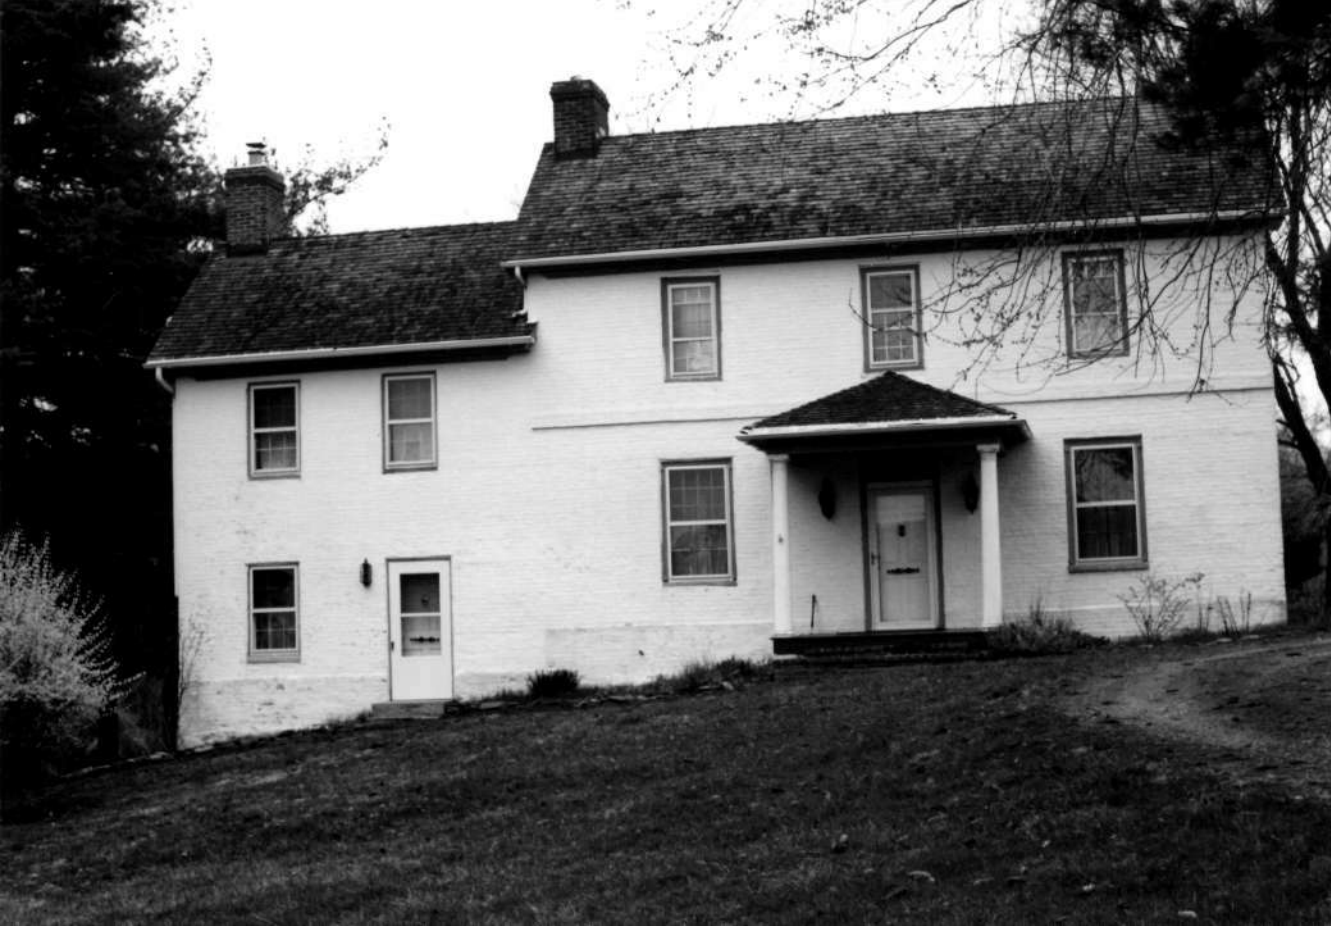
photo 1 of 7

South Facing Front Elevation

The principal (south) façade of the main block is defined by a central doorway flanked by 12/2 sashed windows of the first storey. On the second storey from east to west the three corresponding openings yield 6/6, 6/6, and 9/6 sashed windows respectively. All but the second storey 9/6 sash are replacement shashes in one form or another. Windows on both levels are framed by architrave surrounds with projected wooden sills. Pegging is still evident on most of the window frames. A three-course brick belt course projects between the first and second storeys. A one-storey, one-bay screened portico shelters the main entrance. Tuscan columns serve as supports. The door, framed by a molded surround and single light transom, is six paneled.

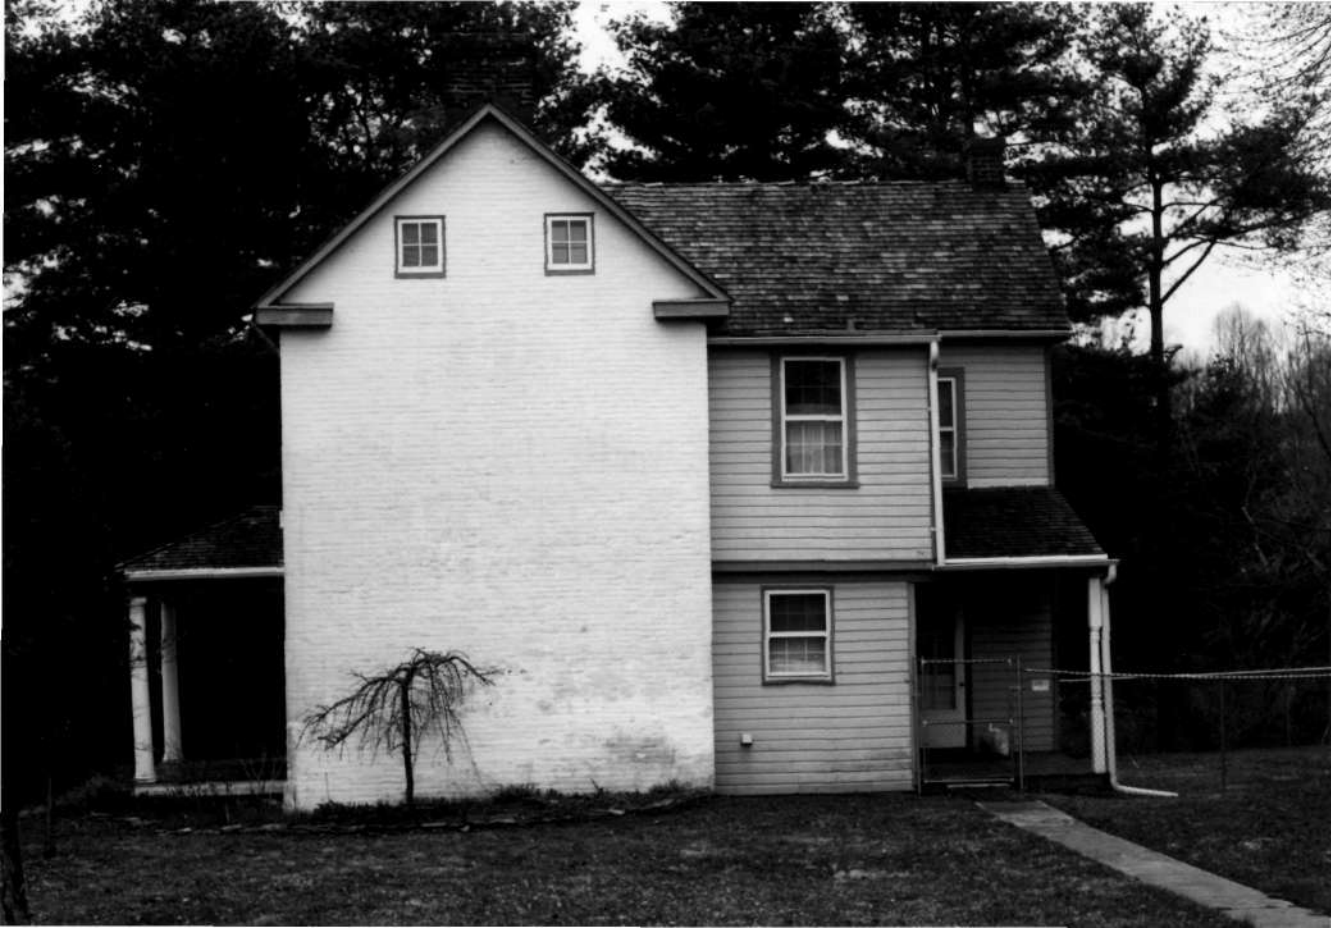
photo 2 of 7

East Facing Side Elevation

The east gable end, laid in common bond brick is distinguished by two, four-light, five-sashed windows at attic level and boxed cornice returns.

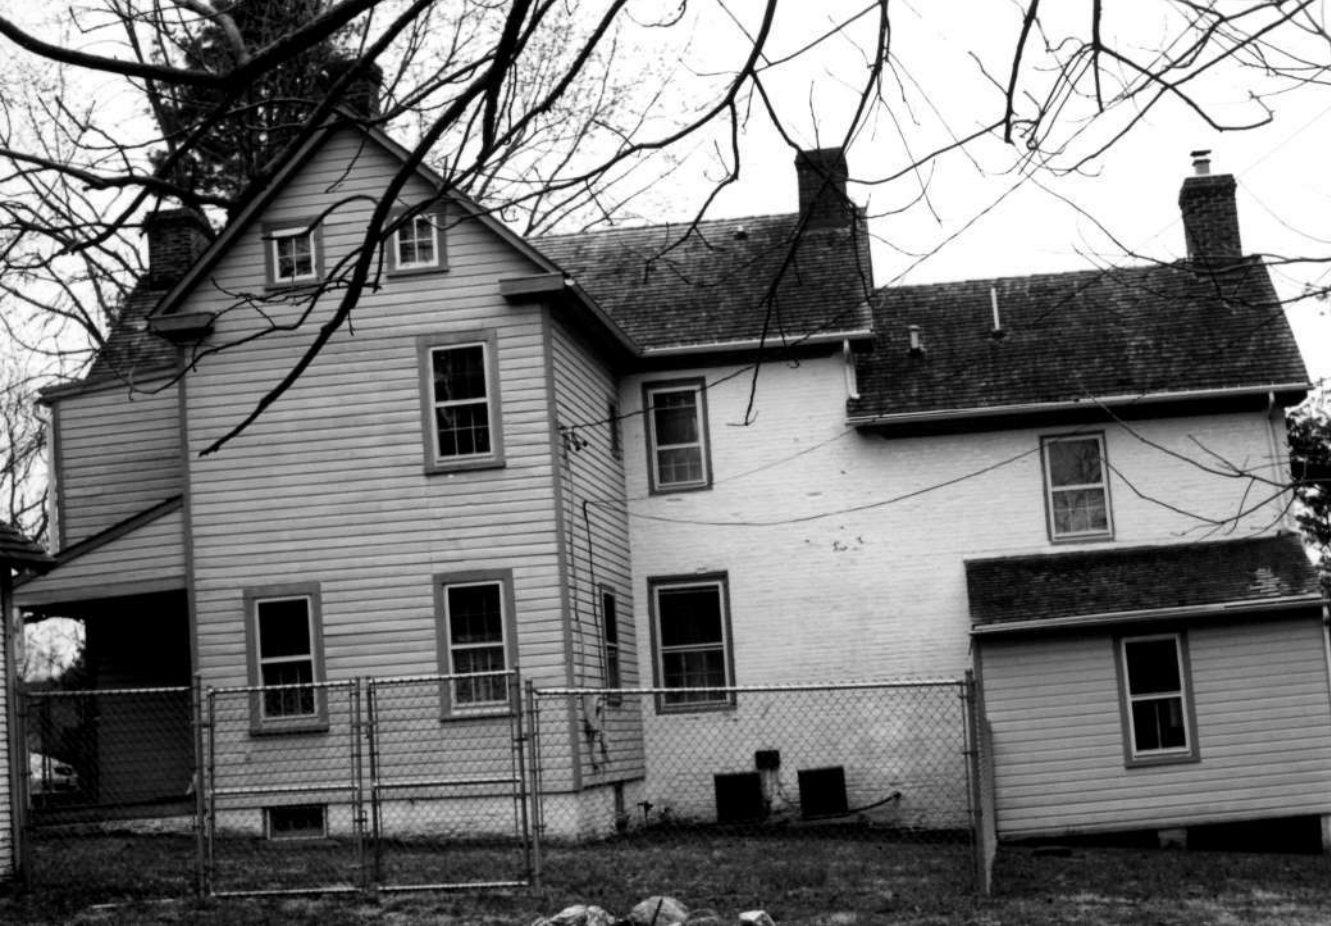
Photo - 3 of 7

North Facing Rear Elevation

On the rear (north) façade, because of the network of frames additions, only the first and second storey windows of the western bay are visible to exterior. The first storey window is 9/6 sash; the second storey window is 6/6. Both are framed by an architraved surround with projecting wood sill.

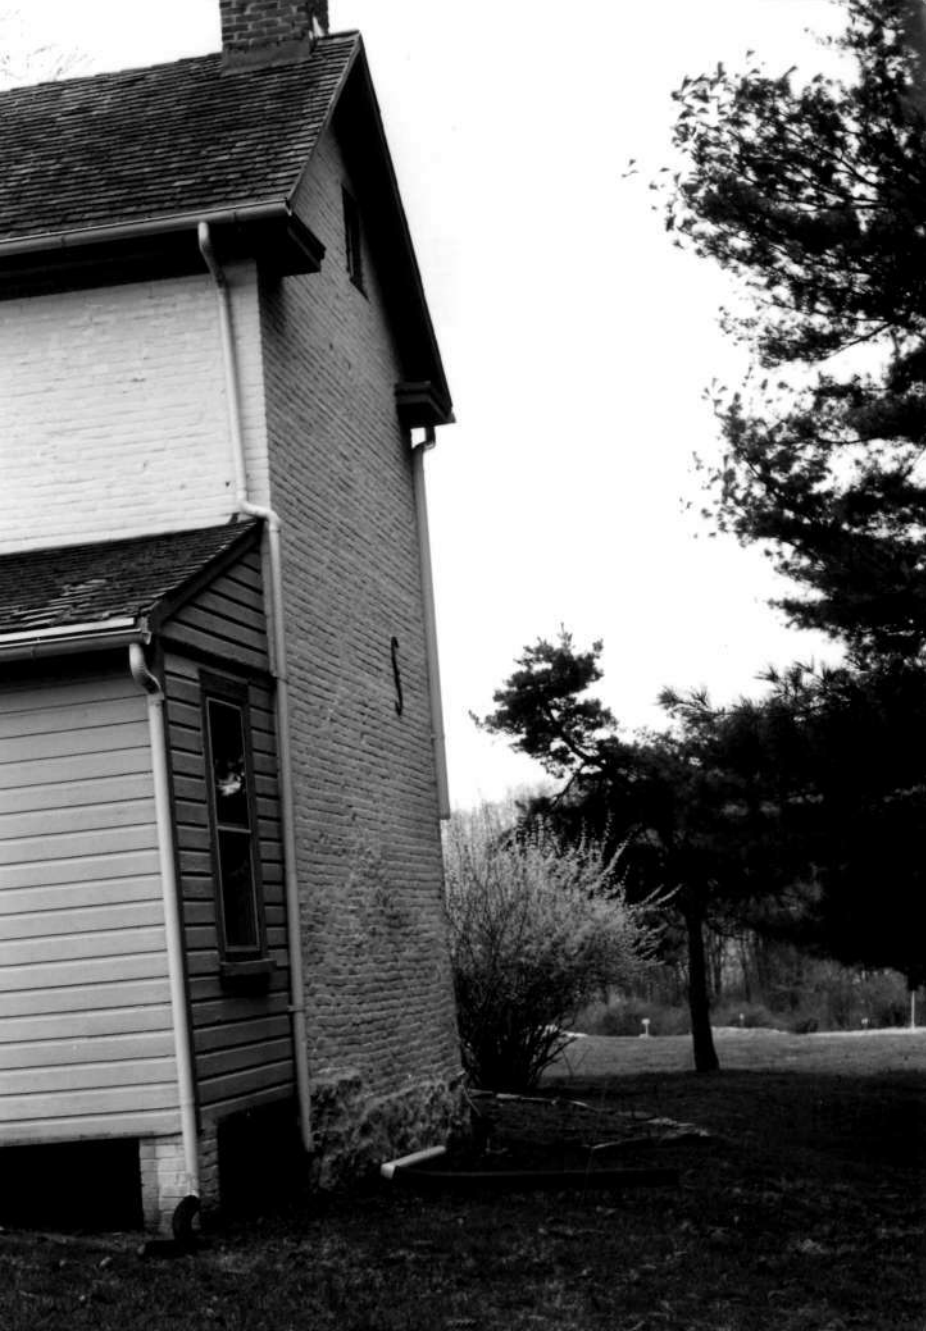
photo 4 of 7

West Facing Side Elevation

The west gable façade yields only the boxed cornice returns.

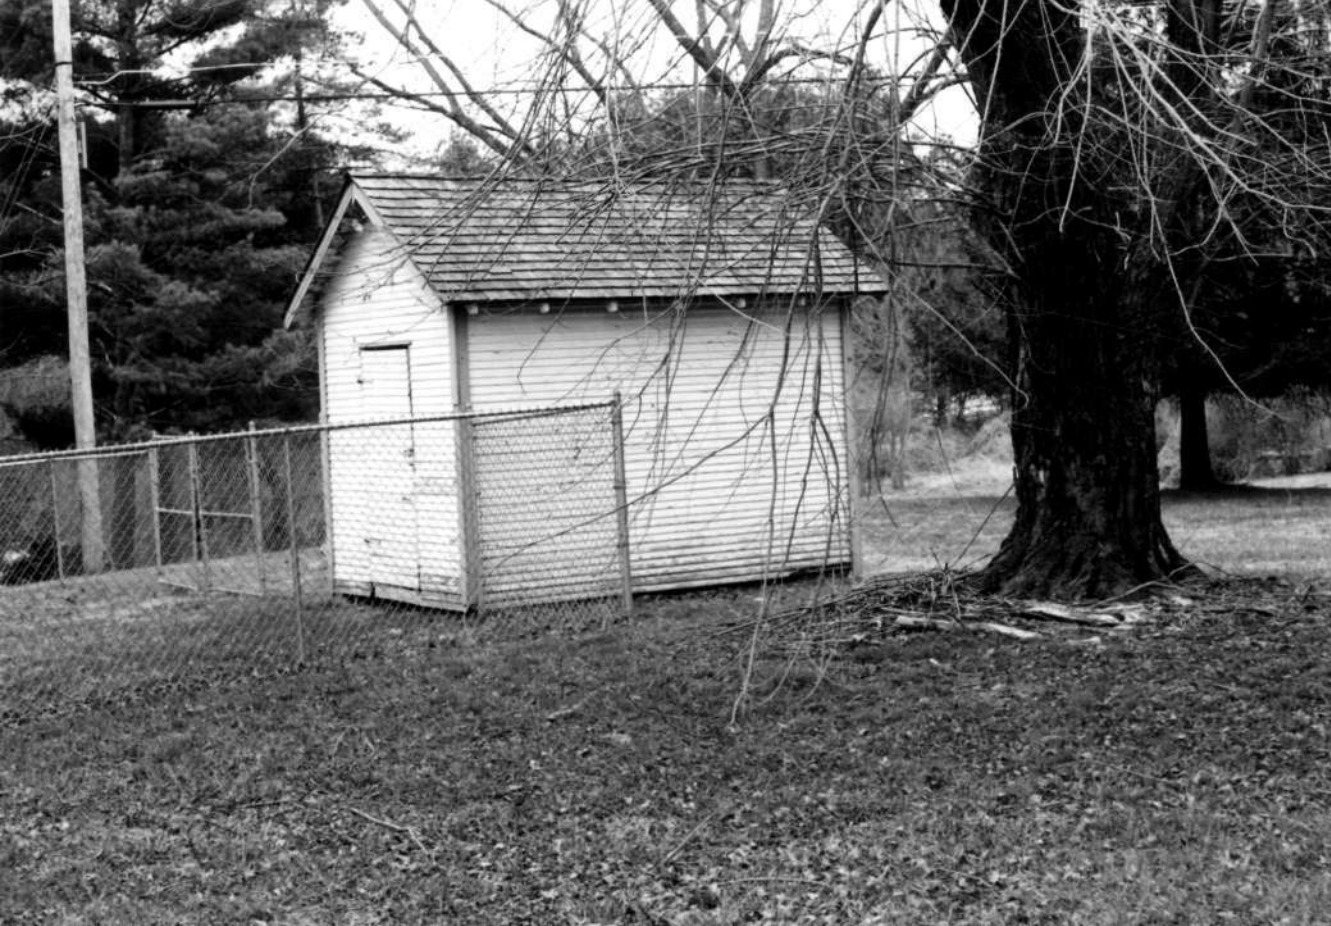
Photo 5 of 7

View north of shed behind farm house

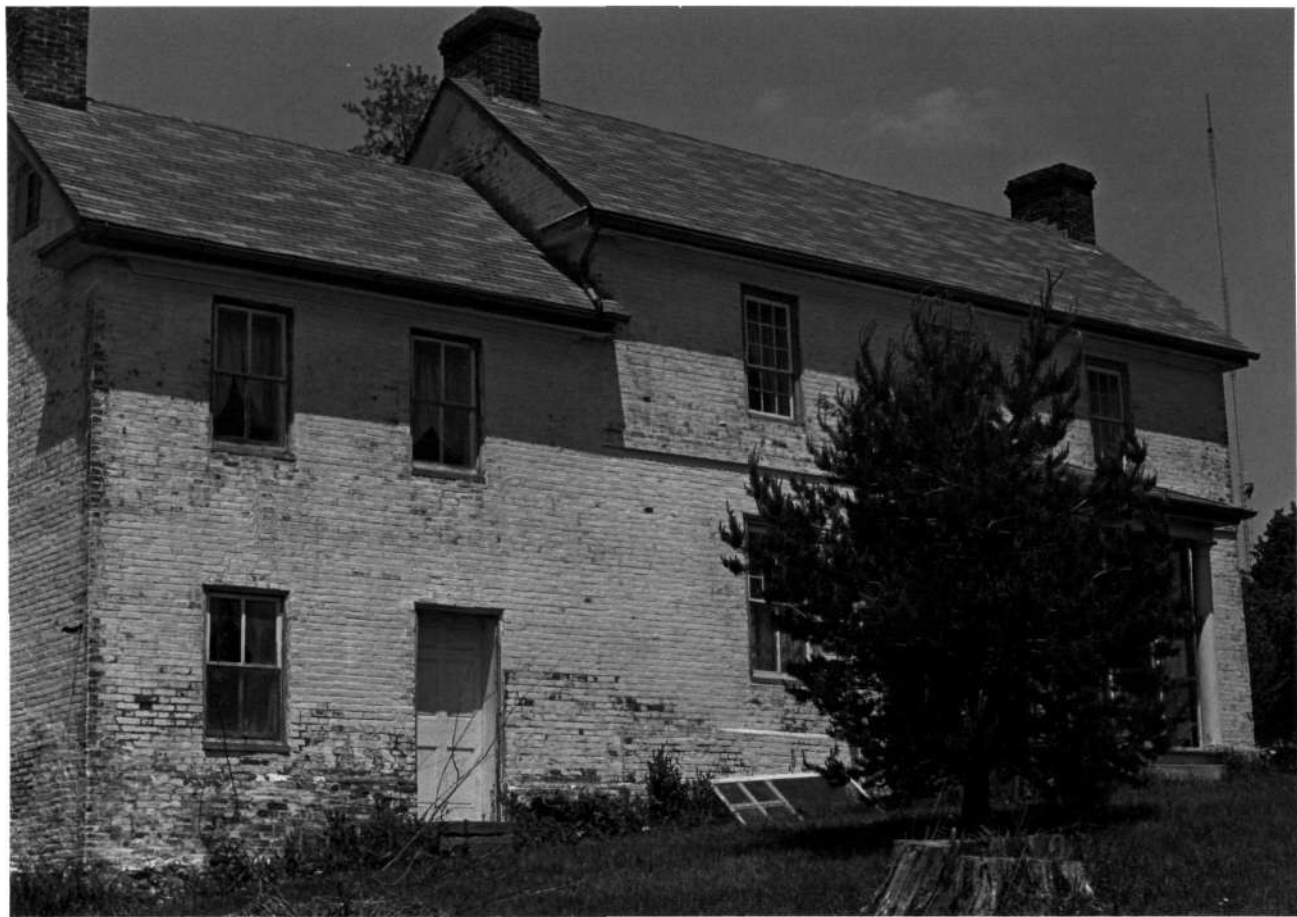
SOUTH ELEVATION

The principle (south) facade of the main block is defined by a central doorway flanked by 12/2 sashed windows of the first storey. On the second storey from east to west the three corresponding openings yield 6/6, 6/6 and 9/6 sashed windows respectively. All but the second storey 9/6 sashed window are replacement sash in one form or another. Windows on both levels are framed by architraved surrounds with projected wooden sills. Pegging is still evident on most of the window frames. A three-course brick belt course projects between the first and second storeys. A one-storey, one-bay screened portico shelters the main entrance. Tucson columns serve as supports. The door, framed by a molded surround and single light transom, is six-paneled.

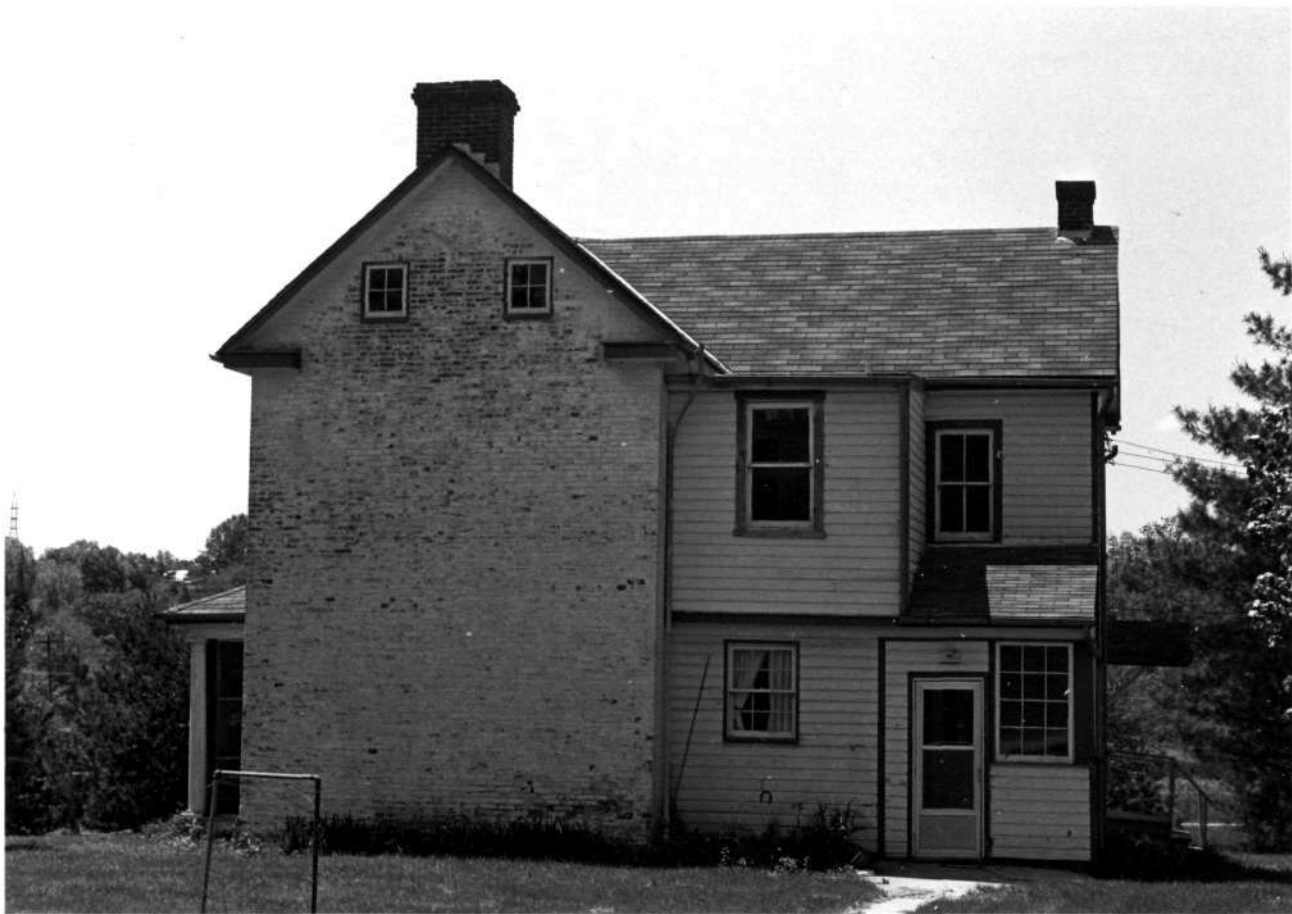
EAST ELEVATION

The east gable end, laid in common bond brick is distinguished by two, four-light, five-sashed windows at attic level and boxed cornice returns.

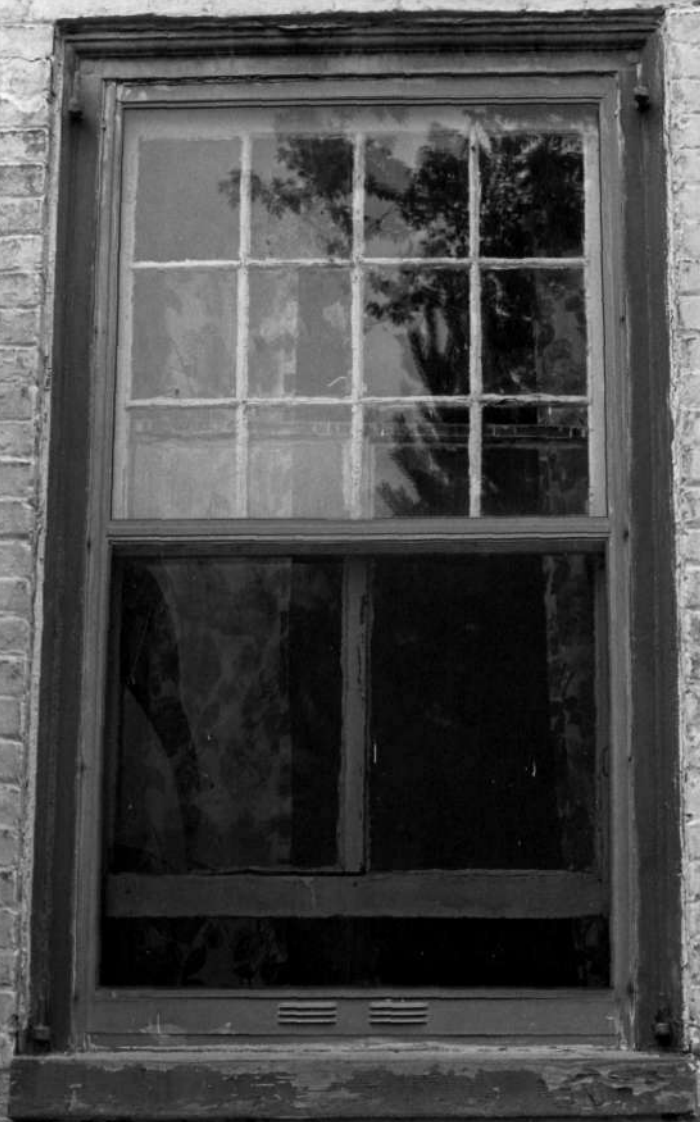
WINDOW DETAIL

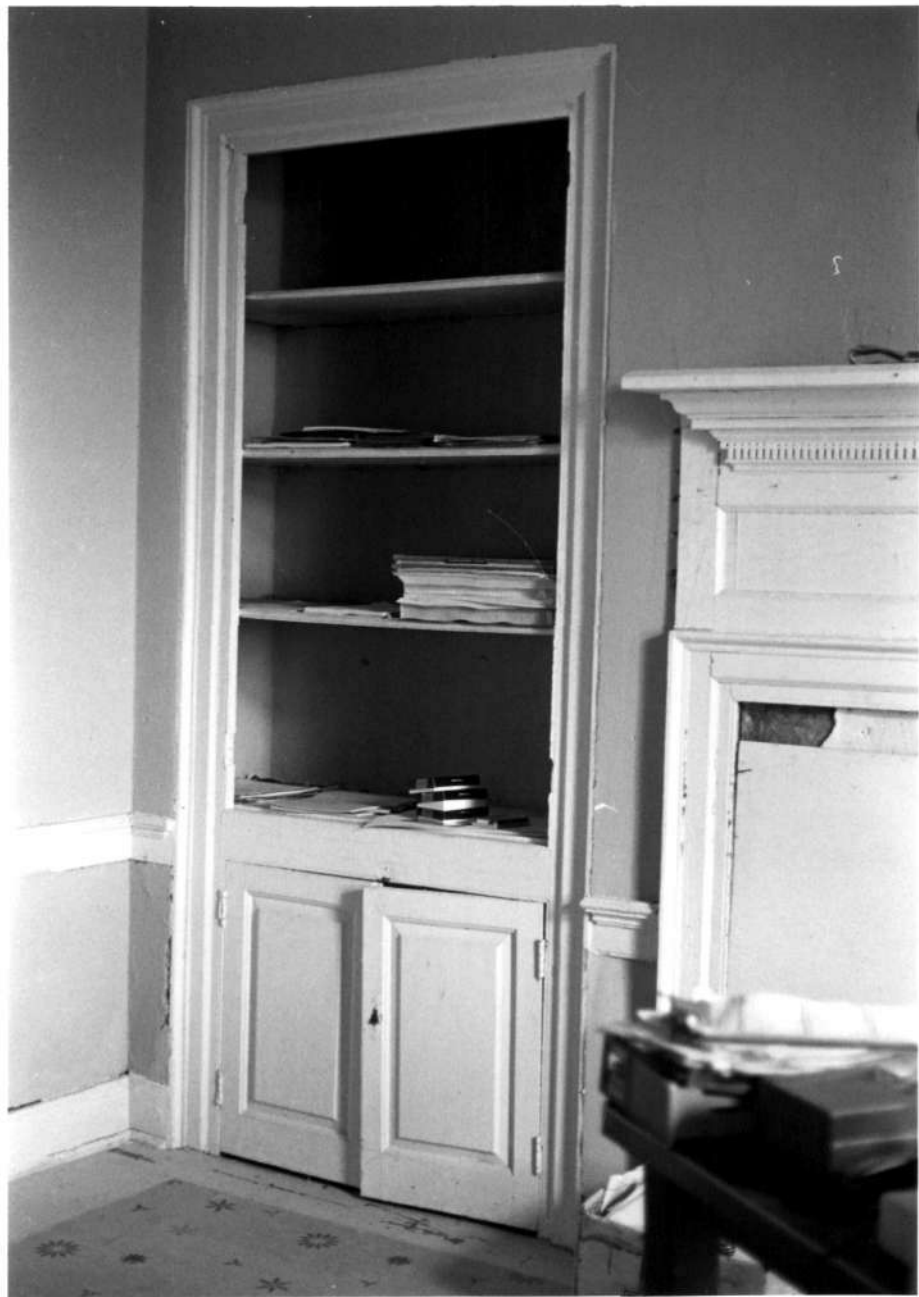
PARLOR MANTEL, CUPBOARD

The main parlor also yeilds molded chairrail and baseboards. Windows are framed by architraved surround. The south window is recessed in an eight inch reveal while the north window is blocked up. An elaborate multi-molded mantel is located on the east wall. It is flanked by built-in cupboards possessing four open shelves above paneled cabinets.
